# Manhole Inspection Summary

Manhole # S19A\_\_023MH

Insp Date: **9/21/09 10:29 AM**

**Location** Address: **807 LANVALE ST**

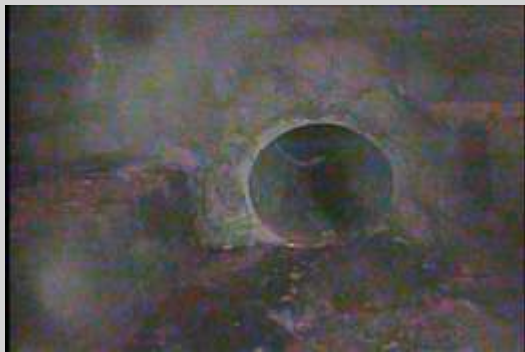
12 O'Clock Outflow

8 in. Circular Gravity Sewer  
Pipe Out @ 12 O'Clock

Pipe Height: **8.4** (in.) Rod and Bar (Angled)  
Pipe Material: **Clay** ☐ Pipe Lined  
Invert Depth: **15.43** (ft.) Flow Characteristics: **Slow**  
Deposits: ☒ None ☐ Mud ☐ Sludge ☐ **Debris** ☐ Grease  
Silt Depth: (in.) Deposits Extent:  
Infiltration: **None** Pipe Seal Cond: **Sound**

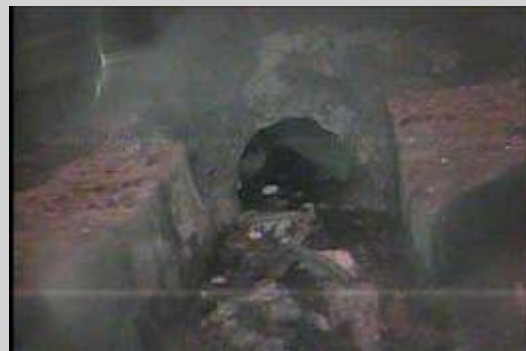
Drop In @ 3 O'Clock

Drop: **Outside** Rod and Bar  
Angled: **Yes** Reading: **14.39** (ft.)  
Inv Depth: **15.39** (ft.)  
Drop Condition: **Open**

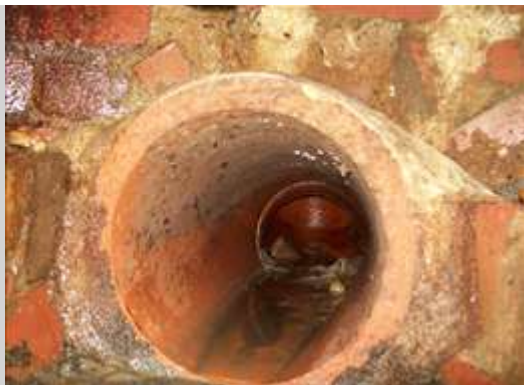
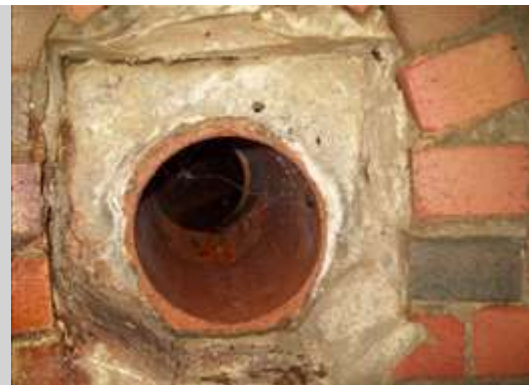
9 O'Clock Inflow

Pipe In @ 9 O'Clock

Drop In @ 9 O'Clock

Pipe Height: (in.) Direct

Pipe Material: **Clay** ☐ Pipe Lined

Infiltration: **None** Pipe Seal Cond: **Sound**

Drop Condition: **Open**
